# REPORT OF THE COMPTROLLER AND AUDITOR GENERAL OF INDIA

## PREPAREDNESS AND RESPONSE TO FLOODS IN KERALA

**Government of Kerala**  
**Report No. 6 of the year 2021**

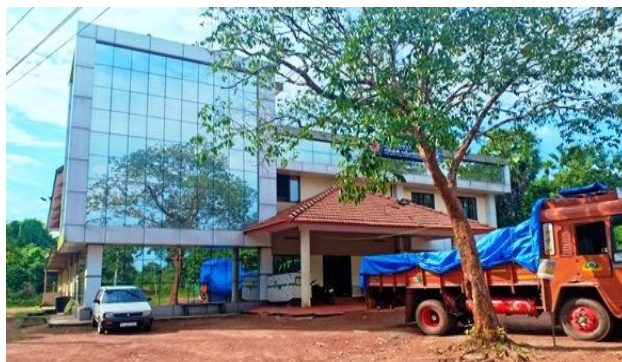
*Figure 2.1: Civil Defence Training Institute Building  
29 October 2019, CDTI, Viyyur, Thrissur District  
Photo taken by Audit party, attested by Director, Fire and  
Rescue Services Academy*

Audit observed that under the scheme ‘Revamping of Civil Defence’ launched by GoI in July 2009, ₹154.20 lakh out of ₹195 lakh received from GoI was expended on construction of a Civil Defence Training Institute (CDTI) at Viyyur in Thrissur district. Joint field verification (October 2019) revealed that though the building, completed in 2014,

was envisaged to function as a State level residential training institute for civil defence under the Fire and Rescue Services Department (F&RSD), it was being utilised as a camping place for members of the National Disaster Response Force (NDRF), with the classrooms and dormitory converted as barracks. Audit observed that the building which was in possession of Revenue Department till April 2018, was handed over to F&RSD on the pre-condition that the NDRF battalion was to be accommodated in the building until a new own building was identified. Joint verification (October 2019) revealed that possession of only a small room had in fact been transferred to the Director

*Recommendation 2.5: The State may initiate action to operationalise the Civil Defence Training Institute for the fulfilment of the intended objective of training and equipping sufficient number of Civil Defence volunteers. Civil Defence needs to be strengthened in the State through ensuring a) adequacy of communication facilities and trained volunteers including availability of licensed HAM radio operators, and b) availability of emergency responder kits to enable timely and effective rescue operation during emergency/ disaster situations.*

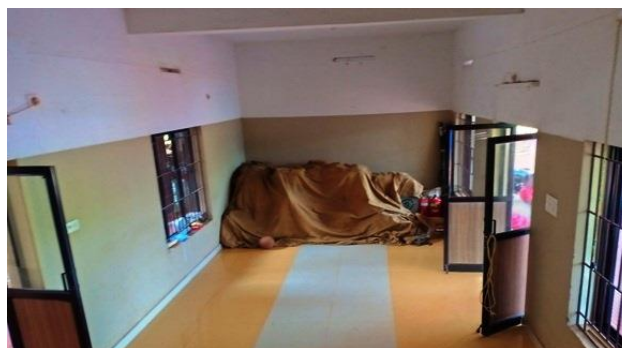
*Figure 2.2: CDTI being used as barracks for NDRF battalion  
and materials being stored in lobby  
29 October 2019, CDTI, Viyyur, Thrissur District  
Photo taken by Audit party, attested by Director, Fire and  
Rescue Services Academy*

of CDTI, which was used for office functioning, with the rest of the building continuing to be occupied by NDRF. The residential training centre to impart training to civil defence volunteers has not become functional despite passage of over five years. Had the State rolled out Civil Defence, selected the volunteers and trained them in a timely manner, the CDTI building could have catered to the envisaged objective.

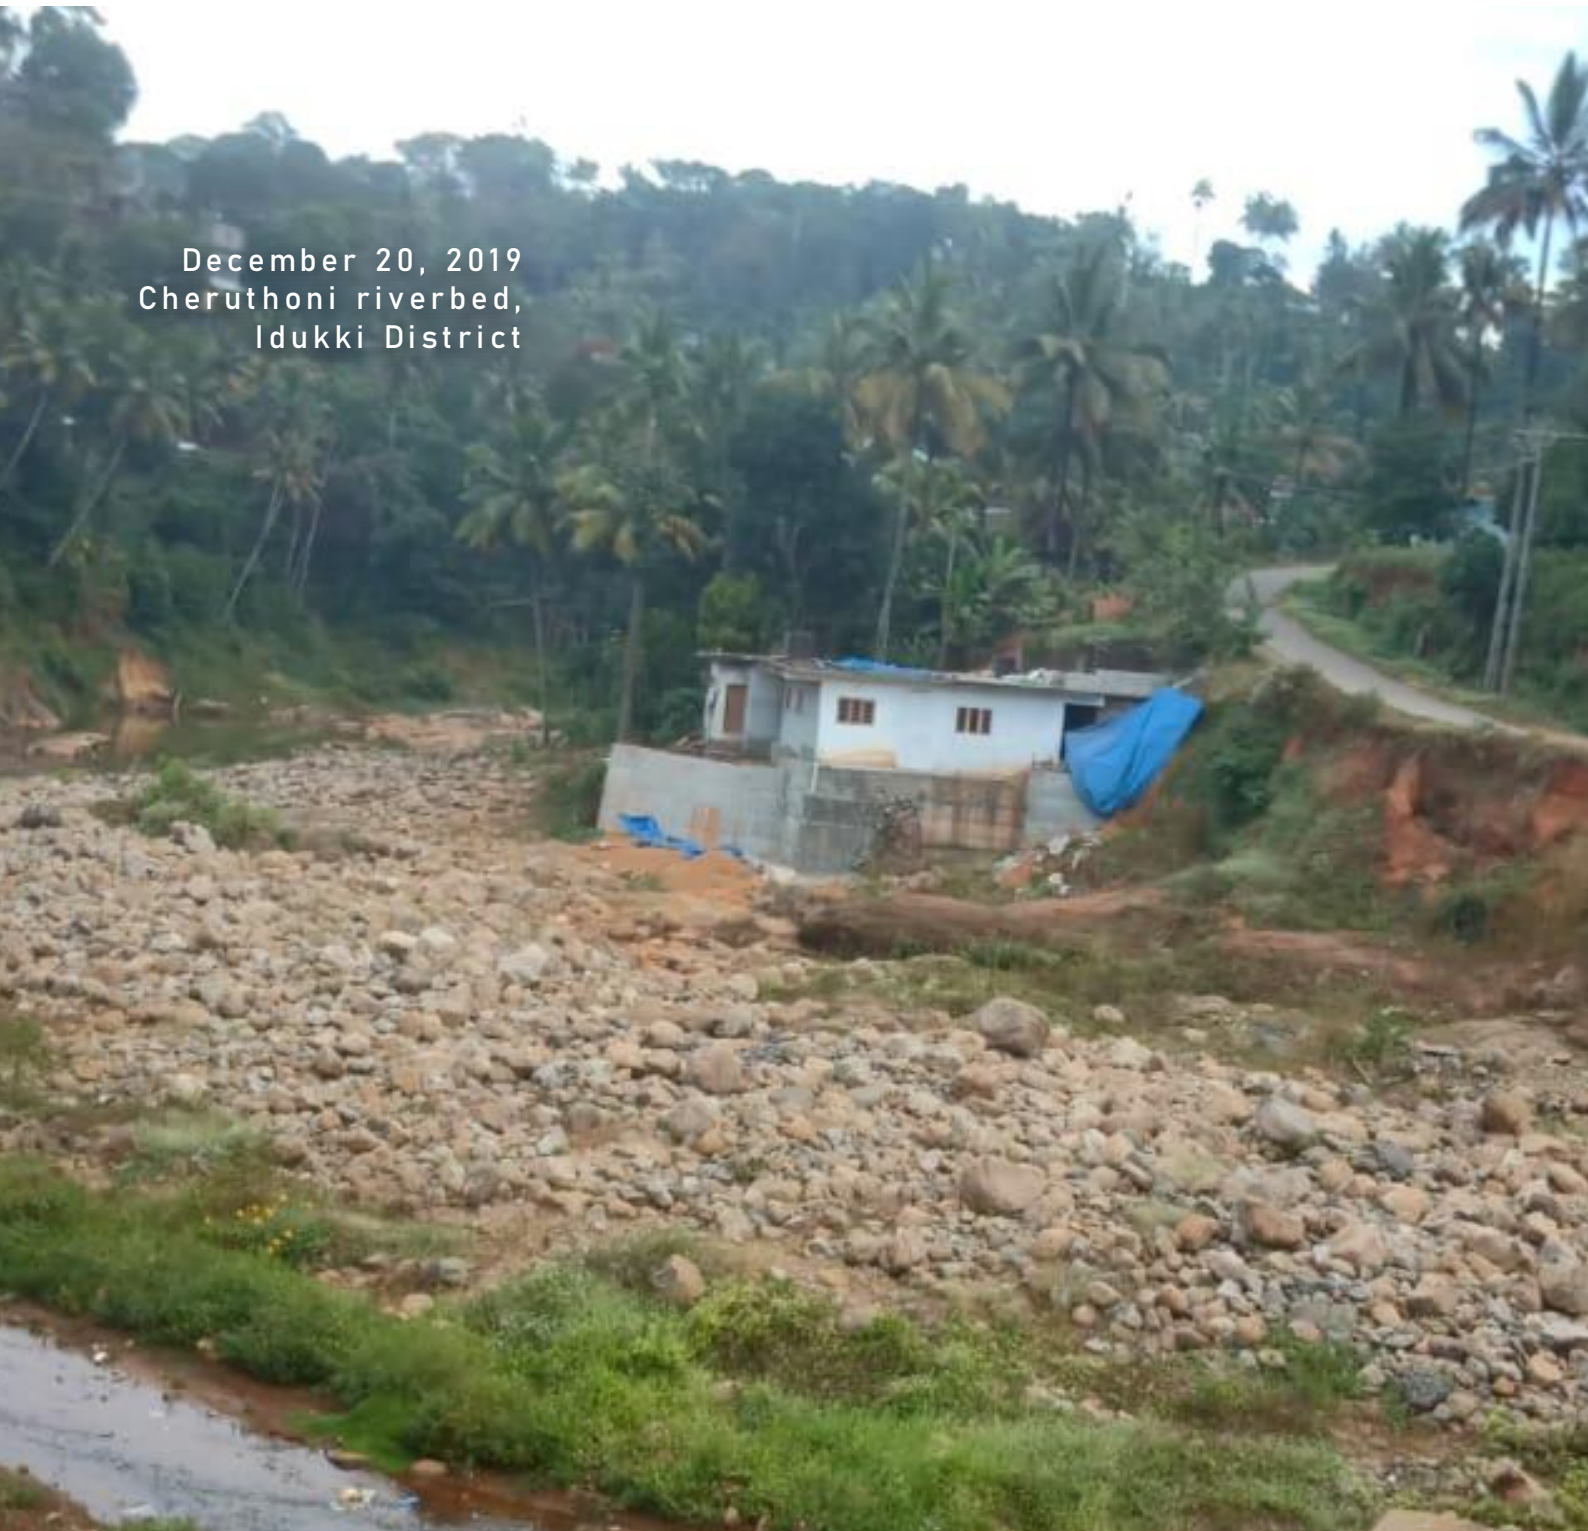
December 20, 2019  
Cheruthoni riverbed,  
Idukki District

Continuing presence of encroachments on Cheruthoni river bed obstructed the free flow of the river resulting in damages during the 2018 floods.
